# **Investigation of Disturbances to Line 5 in the Straits of Mackinac Discovered in May and June of 2020**

UPDATED August 21, 2020

## OVERVIEW AND EXECUTIVE SUMMARY

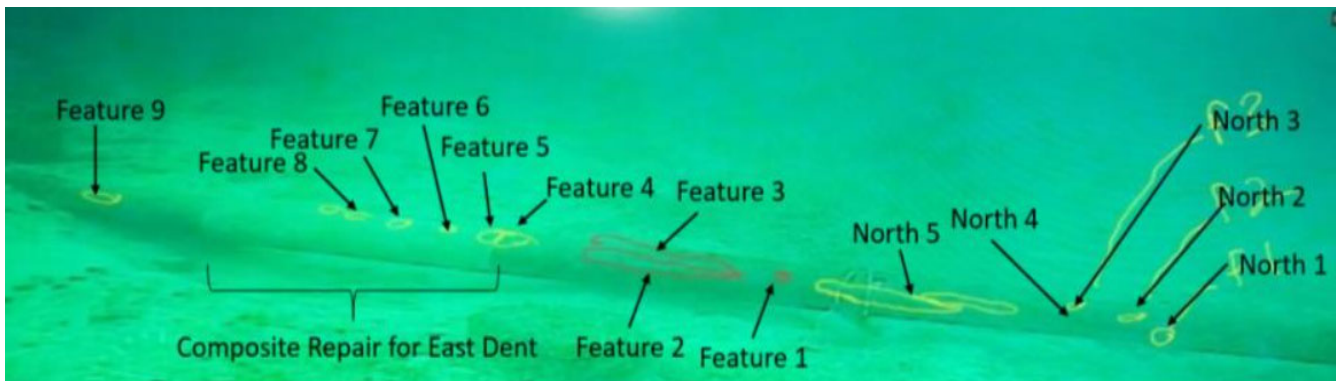
Pipeline engineers analyzed the features and deemed them non-injurious to the pipeline as supported by a fitness for service assessment of the pipeline. Specifically, integrity engineers determined that no safety issue existed based on the assessment of the minor surface scratches, and that only minor coating repairs would be required to address the coating disturbance.<sup>1</sup>

**Figure 1: Coating disturbances at EAP-9 location**

Inspection data is not conclusive but suggests that EAP-9 and EP-17-1 may have been caused by the same event. The direction of force of the EAP-9 coating damage is approximately aligned NNE to SSW. The EP-17-1 disturbance is similarly directionally oriented, with the pipeline support bent (having been pulled) NNE to SSW. Thus, the: (i) close proximity of the two locations; (ii) the similar orientation of the damage; and (iii) the estimated timeframe in which the disturbances occurred all suggest that the two events may have been caused by the same activity.

The coating disturbance at EAP-9 is also consistent with a cable-like object, potentially with something attached to it, dragging over the top of the pipe in a NNE to SSW direction. If a heavier object was involved, there would be an expectation of a more extensive disturbance on the lakebed and pipelines. While the end of a cable seems likely, the possibility of a small vessel anchor cannot be ruled out at this point in the investigation as a possible cause of the damage at EAP-9. The dimensions of the coating disturbances, for example, could be consistent with the type of anchor used for a small to moderately-sized vessel. A large anchor or object dangling from a vessel is unlikely given the lack of identifiable marks in the clay lakebed that would be observable (similar to those still observable in the lakebed resulting from the 2018 anchor strike event).

Based on this analysis, Enbridge performed repairs to the features observed at EAP-9 from May 20 to June 7. This consisted of buffing of surface scratches and performing coating repairs where bare metal was found, pursuant to the work plans previously approved by the State of Michigan and the EPA. Repairs were completed on June 7, 2020. The exterior disturbances observed at EAP-9 no longer exist and the pipe is fully protected.

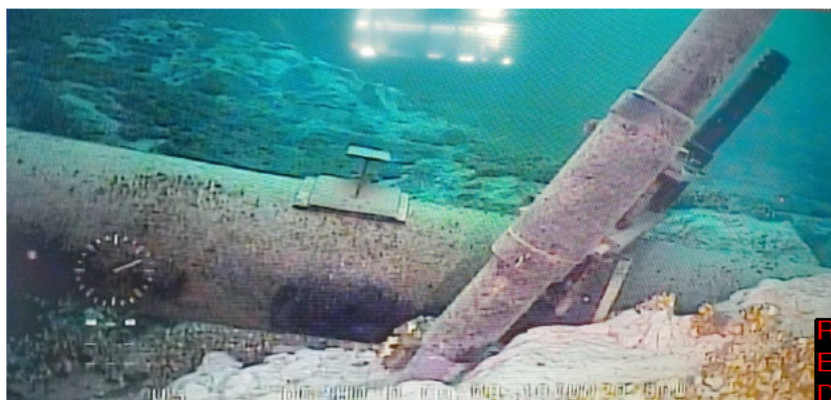
The Engineering Assessment further determined that the lack of a pipeline support at the location of EP-17-1 does not impair the integrity of the pipeline or warrant the installation of a new pipeline support in proximity to that location before operations can resume. This is due to the fact that even following the damage to EP-17-1 and its subsequent removal, the pipe on either side of EP-17-1 was supported by nearby clay touchdown points that limited the length of unsupported pipe at this location to be 66 feet. Importantly, Enbridge has also recently installed an additional support (EAP-7) approximately 58 feet north of EP-17-1. Even though a pipeline support is not required at this location for purposes of safety or compliance with the 1953 Easement, Enbridge has submitted requests to

**Figure 2: EP-17-1 pipe support**

the US Army Corps of Engineers and Michigan Department of Environment, Great Lakes, and Energy (EGLE) to modify its existing permits to install a new pipeline support in proximity to EP-17-1.<sup>2</sup> EGLE has already granted the modification to the existing permit necessary to perform the installation; the Army Corps has determined that a nationwide permit may be used, but is also engaging in Tribal consultation on Enbridge's use of the permit. That pipeline support will be installed upon obtaining the necessary regulatory approvals.

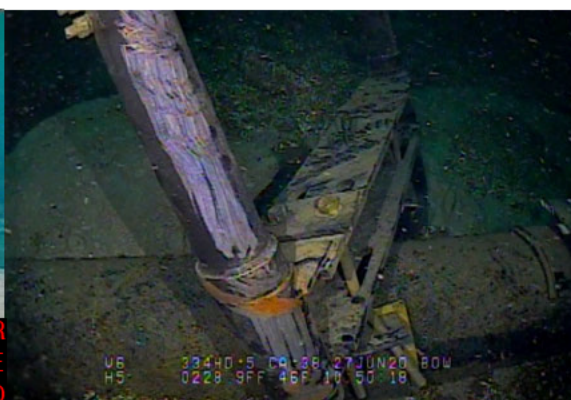
**Figure 3: Cable marks on EP-17-1 pipe support**

Following the discovery of the disturbances at EAP-9 and EP-17-1, Enbridge conducted a full visual inspection of the East and West Lines. Based on the existence of cable markings on the damaged pipeline support at EP-17-1 (as depicted in Figure 3 above) and lack of anchor marks on the pipeline support or in the surrounding clay lake bottom,<sup>3</sup> it is believed that a cable-like object suspended from a vessel at the surface became entangled around the pipeline support, pulling it in a NNE to SSW direction.

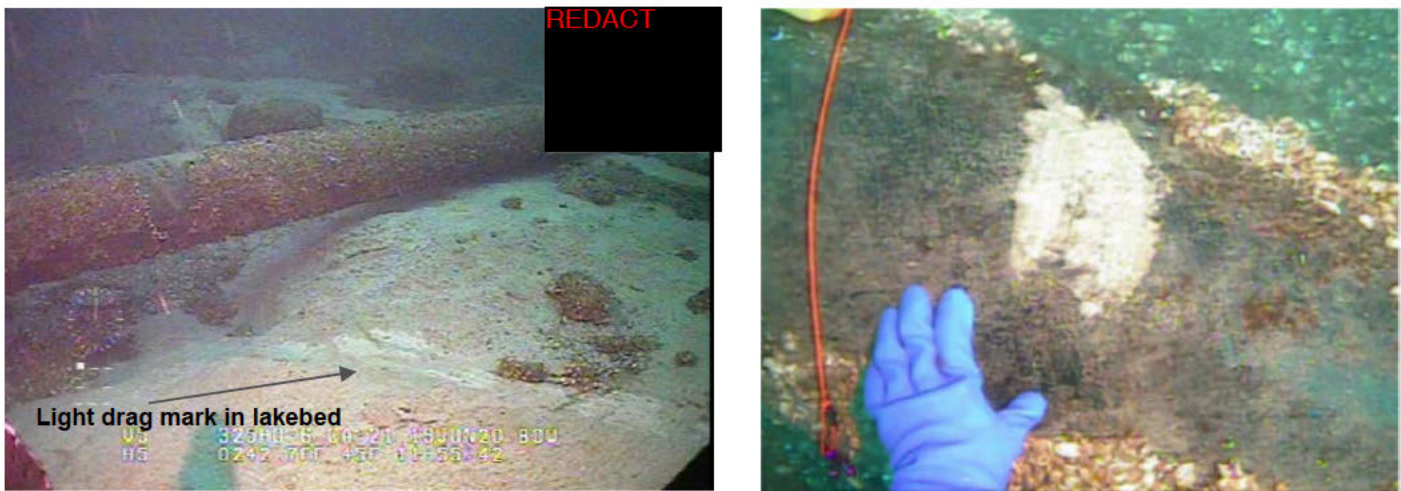
Images of the West Line and East Line Features of Interest are provided in Figure 4 below, along with the light drag mark observed in the clay lakebed.

**Figure 4: West Line Feature of Interest and East Line Feature of Interest**

Adjacent to the West Line Feature of interest, a light track in the lakebed was identified through ROV inspection. The light track was found to extend between the East and West Lines, with similar evidence of removed biota and the formation of a calcareous deposit on the East Line (East Line Feature of Interest). The light track was found to extend in either direction, in an east-to-west (or west-to-east) alignment, consistent with vessels transiting the shipping channel. Due to the minimal depth of the light track, along with the fact that no damage to the East or West Line pipes occurred (i.e., the Features consist of only removed biota and some coating disturbance), it is believed that the light mark was the result of a dangling cable or a small vessel anchor; a heavy ship anchor would have left a deeper impression in the clay lakebed.

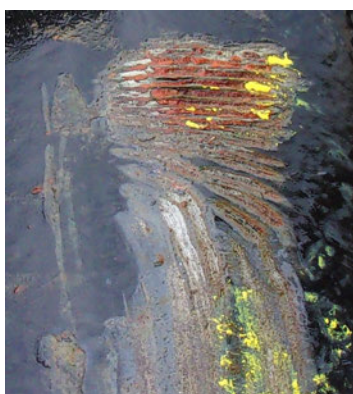
Scanning Electron Microscopy (SEM) and Energy Dispersive X-Ray Spectroscopy (EDS) were conducted on the surfaces of the cross-member of the support structure where evidence of gouging was found. Metallurgical cross sections were also taken from these same locations. Based on the visual examination and SEM results, the gouge marks are consistent with a steel cable. The wear morphology (determined by the SEM 10X to 500X magnification) indicates that the cable slid across the pipeline support in an East to West direction, consistent with a vessel pulling that cable at the water's surface in a NNE to SSW direction. Though sizing of the cable is not possible to ascertain from assessment of the cross sections alone, the gouge striations were determined to be roughly 2 mm in diameter. The gouge marks and striations sizes are consistent with either a 1-1/8" 6x26 IWRC or a 1-1/2" 6x36 steel cable, which are typical of what is used for marine mooring applications.

**Figure 5: Example of Gouged Area**

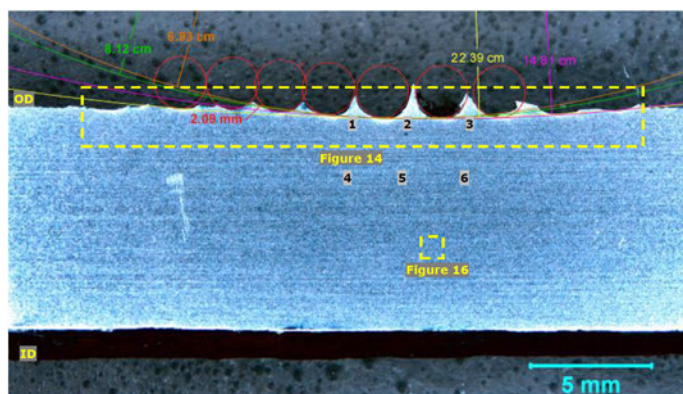
**Figure 6: Metallurgical Cross-Section of Gouged Area**

Energy Dispersive X-Ray Spectroscopy (EDS) was used to assess whether or not evidence of organic (i.e. paint) or inorganic (i.e. zinc) coating present in the gouged areas. No evidence of organic or inorganic coatings were detected, leading to the conclusion that the cable was a bare steel cable.

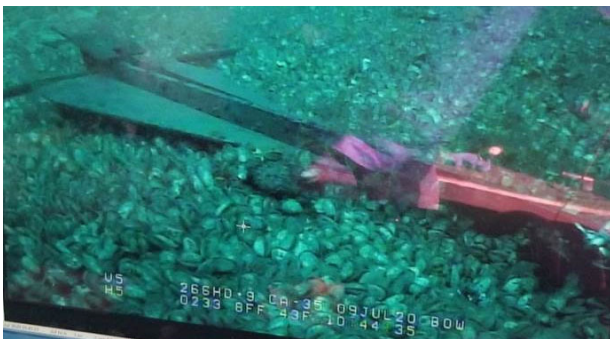
Enbridge notes that it discovered and recovered a small Danforth-style anchor, likely from a small vessel, lying on the lakebed of the Straits approximately one foot from the light track mentioned above and at a location approximately 1,500 feet West of the West Leg. The light track extends alongside and beyond the anchor location, suggesting that the anchor was not the cause of the Features of Interest. Based on visual inspection of the anchor (Figures 7 and 8 below), there is no definitive evidence to support a conclusion that the recovered anchor was the cause of the damage/disturbances at EAP-9, EP-17-1, or the Features of the Interest.

**Figure 7: Danforth-style Anchor as discovered on lakebed**

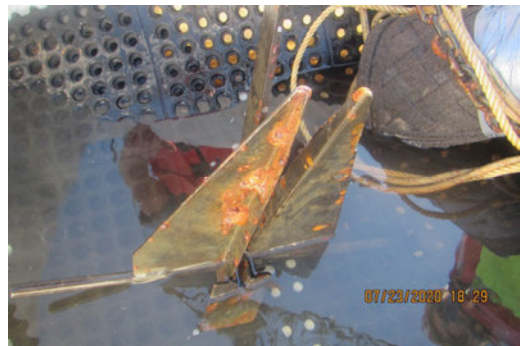
**Figure 8: Danforth-style Anchor as recovered**

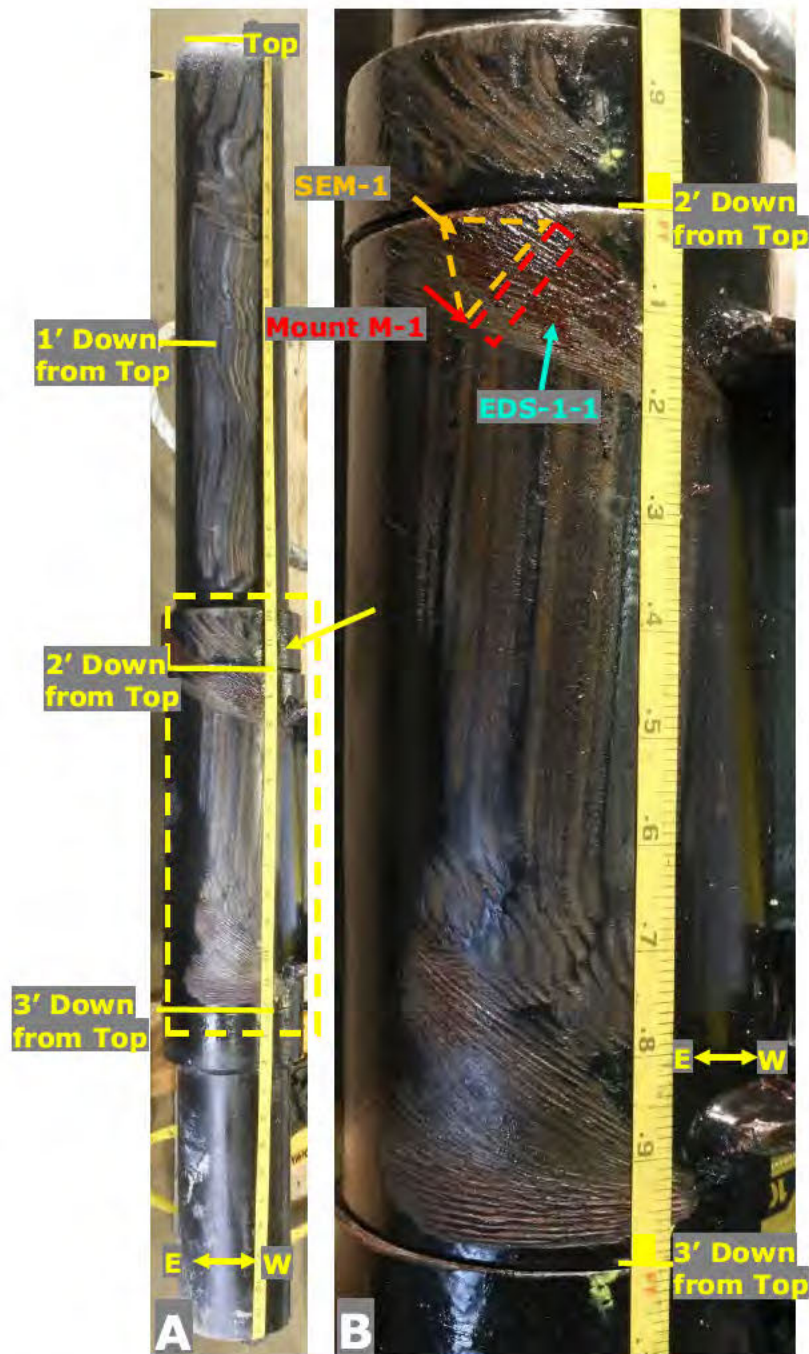
Figure 2. Photographs of Anomaly 1 located on the OD surface of the East Sleeve Ring (showing North side of assembly) and locations of Mount M-1, SEM-1 and EDS-1. (A) shows entire East Sleeve Ring, (B) shows close-up of anomaly. Location indicated in Figure 1. Tape measure indicates distance down from top of assembly in feet.

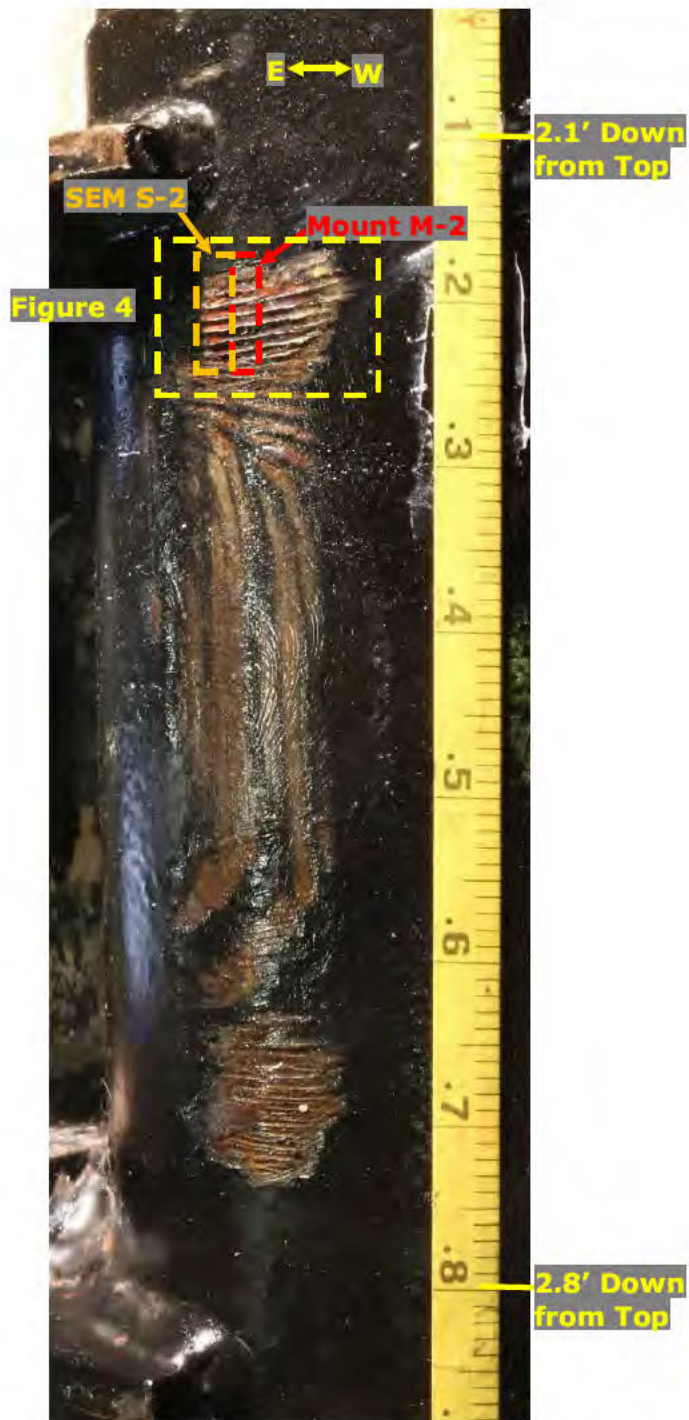
Figure 3. Photograph of Anomaly 2 located on OD surface of the West Sleeve Ring (North side of assembly), and locations of Mount M-2 and SEM-2. Location shown in Figure 1. Tape measure indicates distance down from top of assembly in feet.

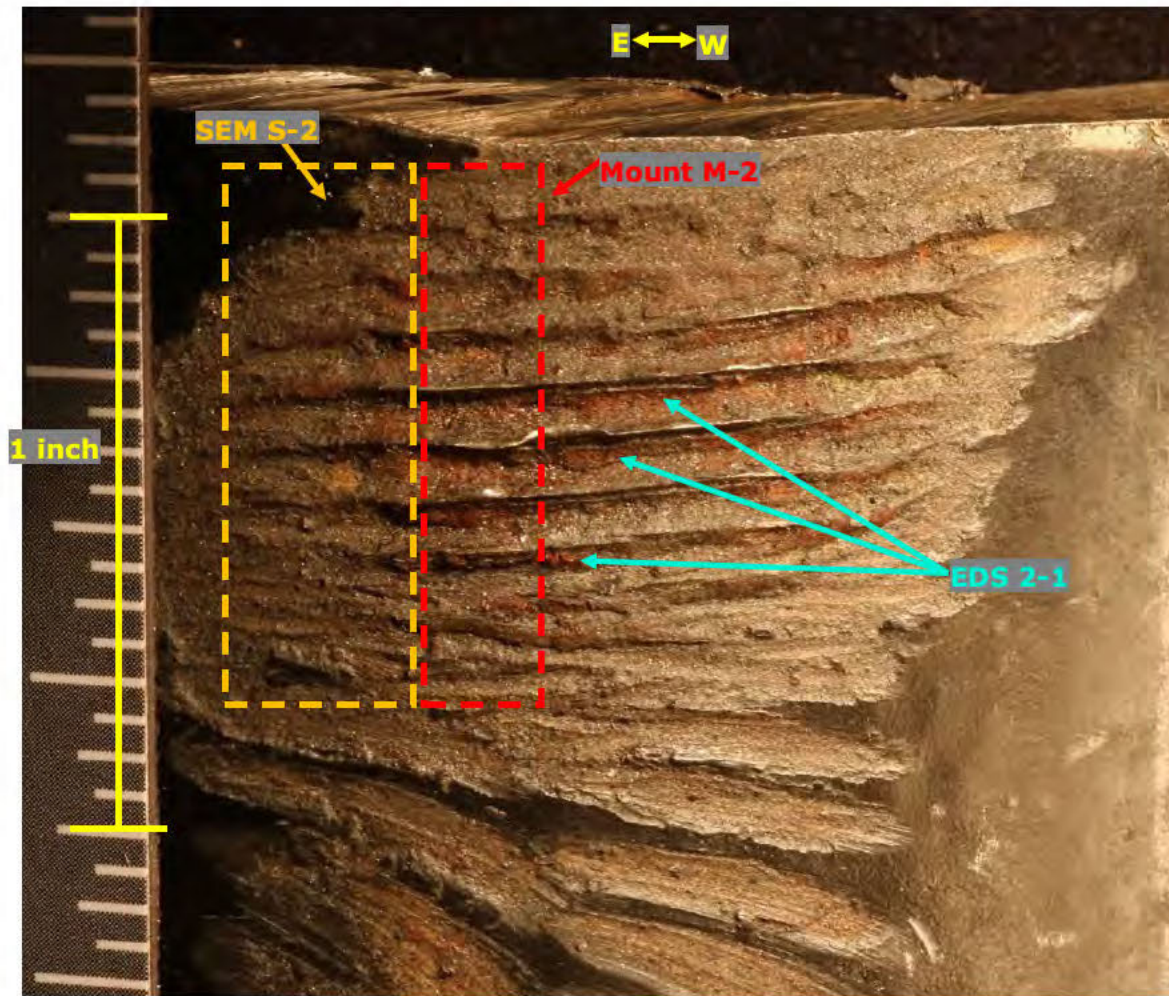
Figure 4. Close-up photograph of Anomaly 2 on OD surface of West Sleeve Ring (North side of assembly), and the locations of Mount M-2, EDS 2-1 and SEM-2. Location shown in Figure 3. Ruler for reference in inches.

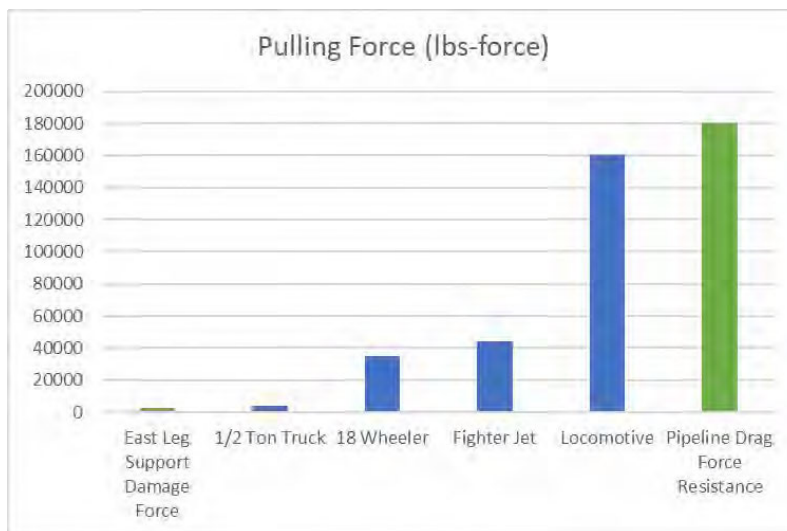
The maximum force on the support anchor would have been due to dragging it in the longitudinal direction (i.e. along the axis of the pipe). The limiting point on the anchor is the slip force of 2600 lbs friction load which occurs at the saddle component and is the interface between the anchor and the pipe. This dragging force equates to less than 0.054 ksi or less than 0.18% specified minimum yield strength (SMYS) of the pipe.

Figure 1: Comparison of Drag Force that Occurred at the Anchor to Sample Scenarios

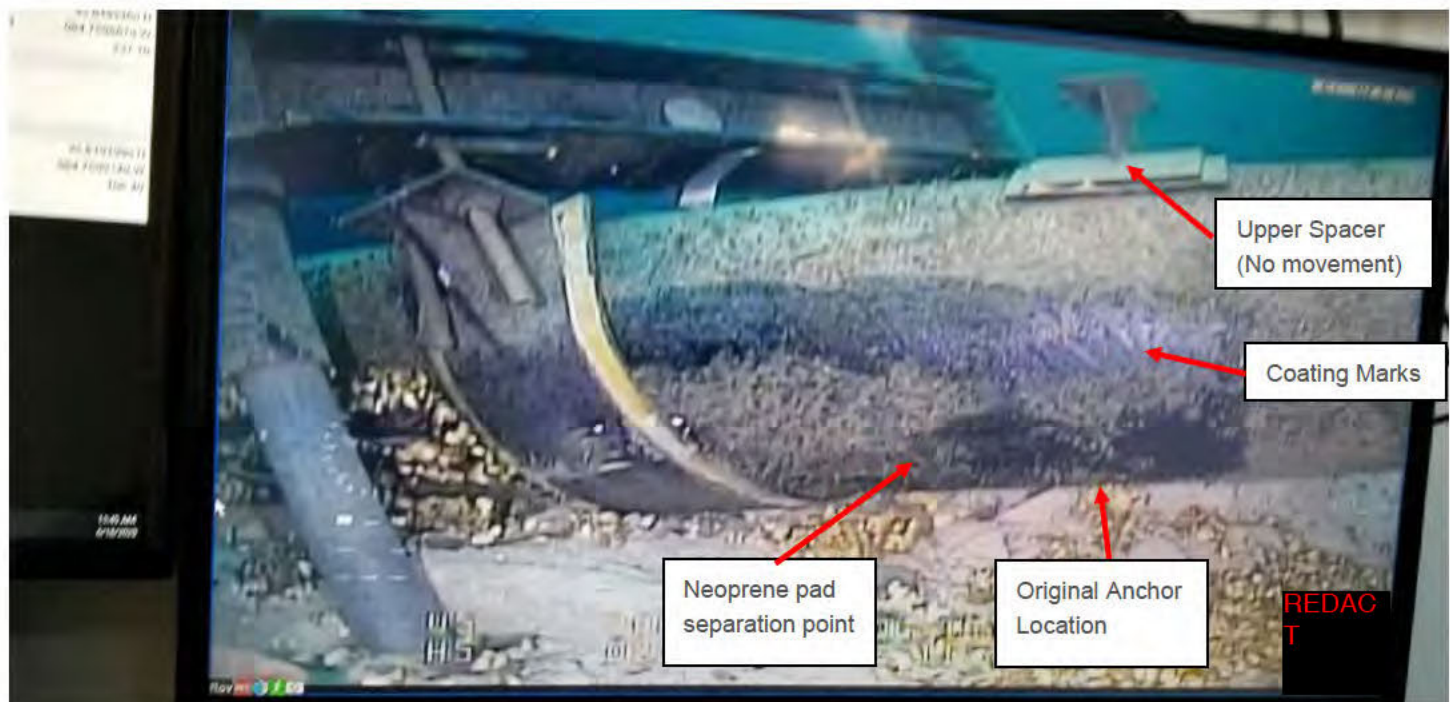
Figure 2: Displaced Anchor looking West

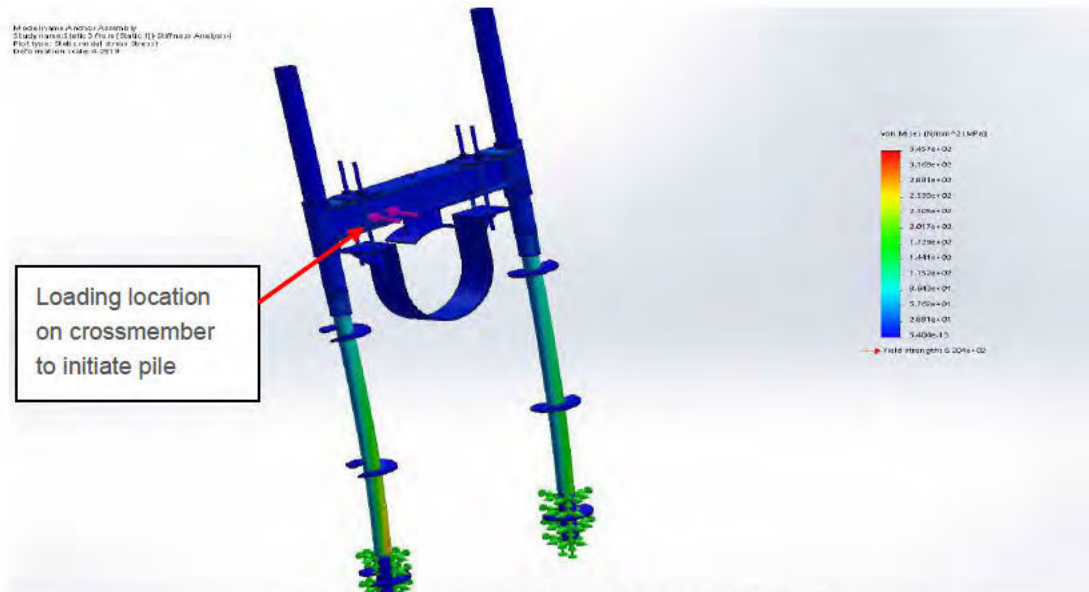
yield strength of the pile is reached, there is relatively little increase in load to continue deforming the anchor assembly. The loading condition shown in Figure 3 below has the loading of the cross-member where it meets the East helical screw pile. This loading condition matches the as found deformed shape of the assembly when viewed from above as shown in Figure 4 below. Also, the reduced stresses within the West helical screw pile in Figure 3 support this loading condition.

Figure 3: Required loading to yield the helical anchor

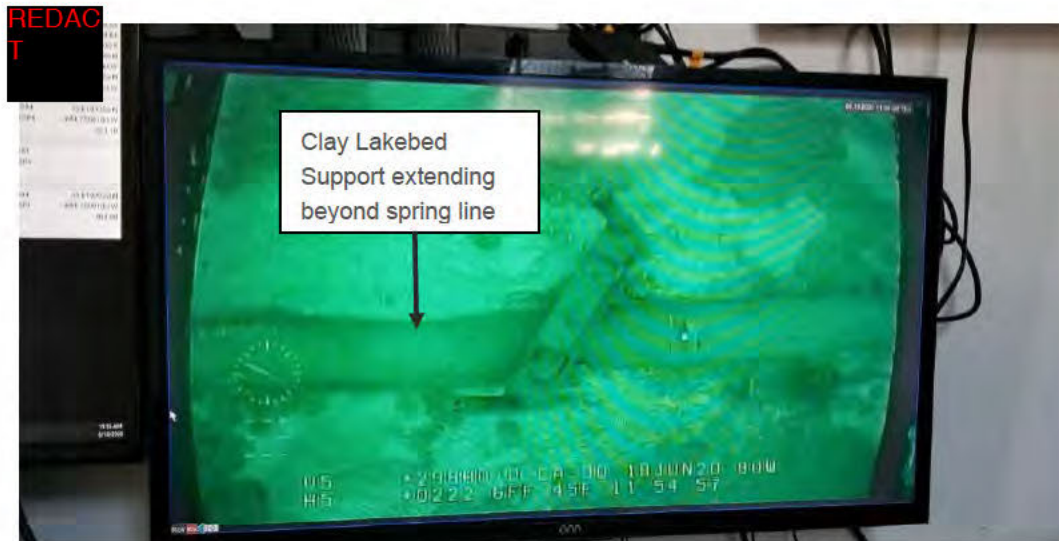
Figure 4: View from above showing the increased deflection within the East helical pile

The pipe is currently sitting on clay material nearby the damaged support anchor as shown in Figure 4 above and Figure 5, below. The clay touchdown serves as a support point and is 66 ft from the next anchor. This new pipe span of 66 ft is shorter than the remediation target of 75 ft, as stipulated within the requirements of the Line 5 Straits Easement Agreement. The 75 ft target provides a 2x safety factor. The 3<sup>rd</sup> Consent Decree additionally stipulates that locations identified beyond 65 ft span will require assessment and determination for remediation. The damaged anchor is incapable of carrying any measurable pipeline load due to the damaged and mis-aligned 1-inch threaded rods, as well as the gap between the top cross member and the pipeline as shown in Figure 5 below. This indicates that the maximum vertical load that can be imparted to the pipe is limited to the bending load of the failed 1" threaded rods and that the existing damaged anchor does not provide sufficient span management. As such, in order to meet the requirements of the Consent Decree, a replacement anchor will be scheduled for install in the near term once the required permit modifications are approved by both USACE and EGLE.

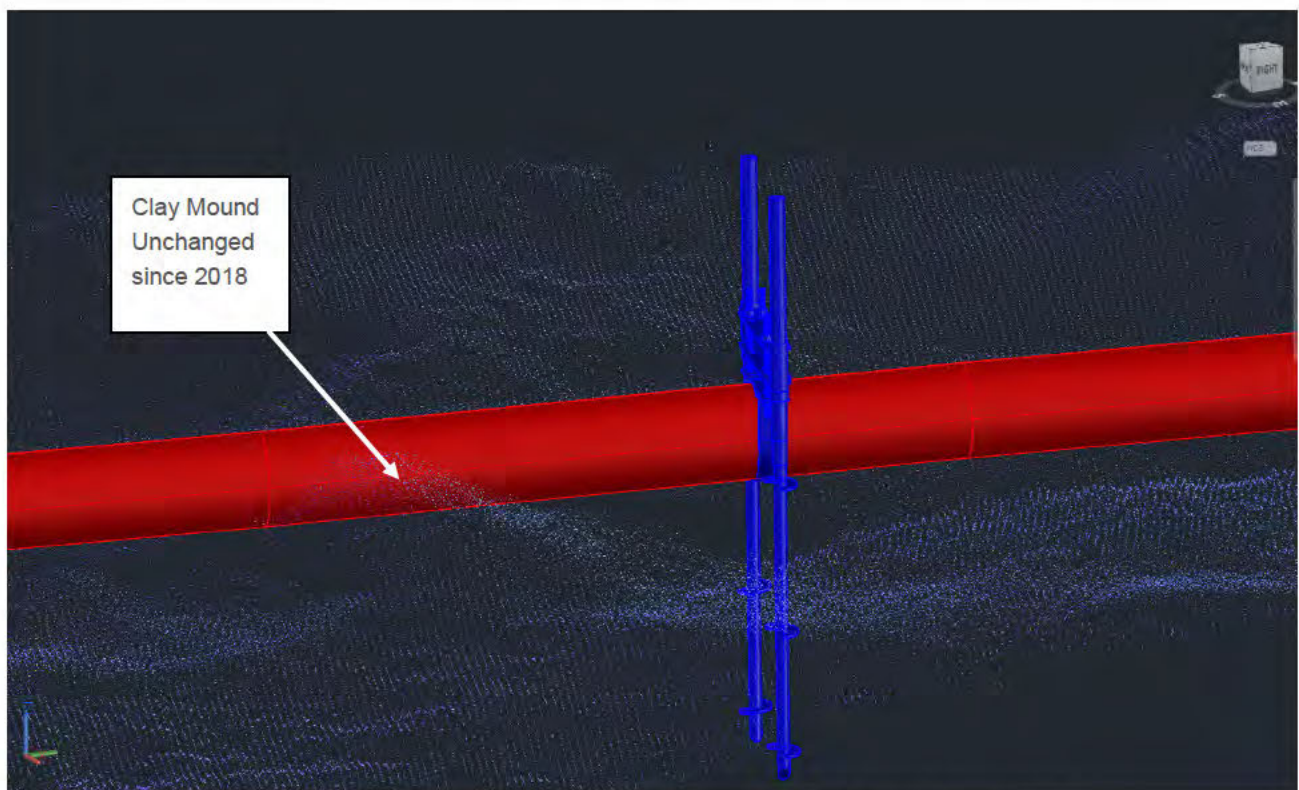
Figure 5: Multibeam bathymetry of EP-17-1 in relation to the adjacent clay mound.

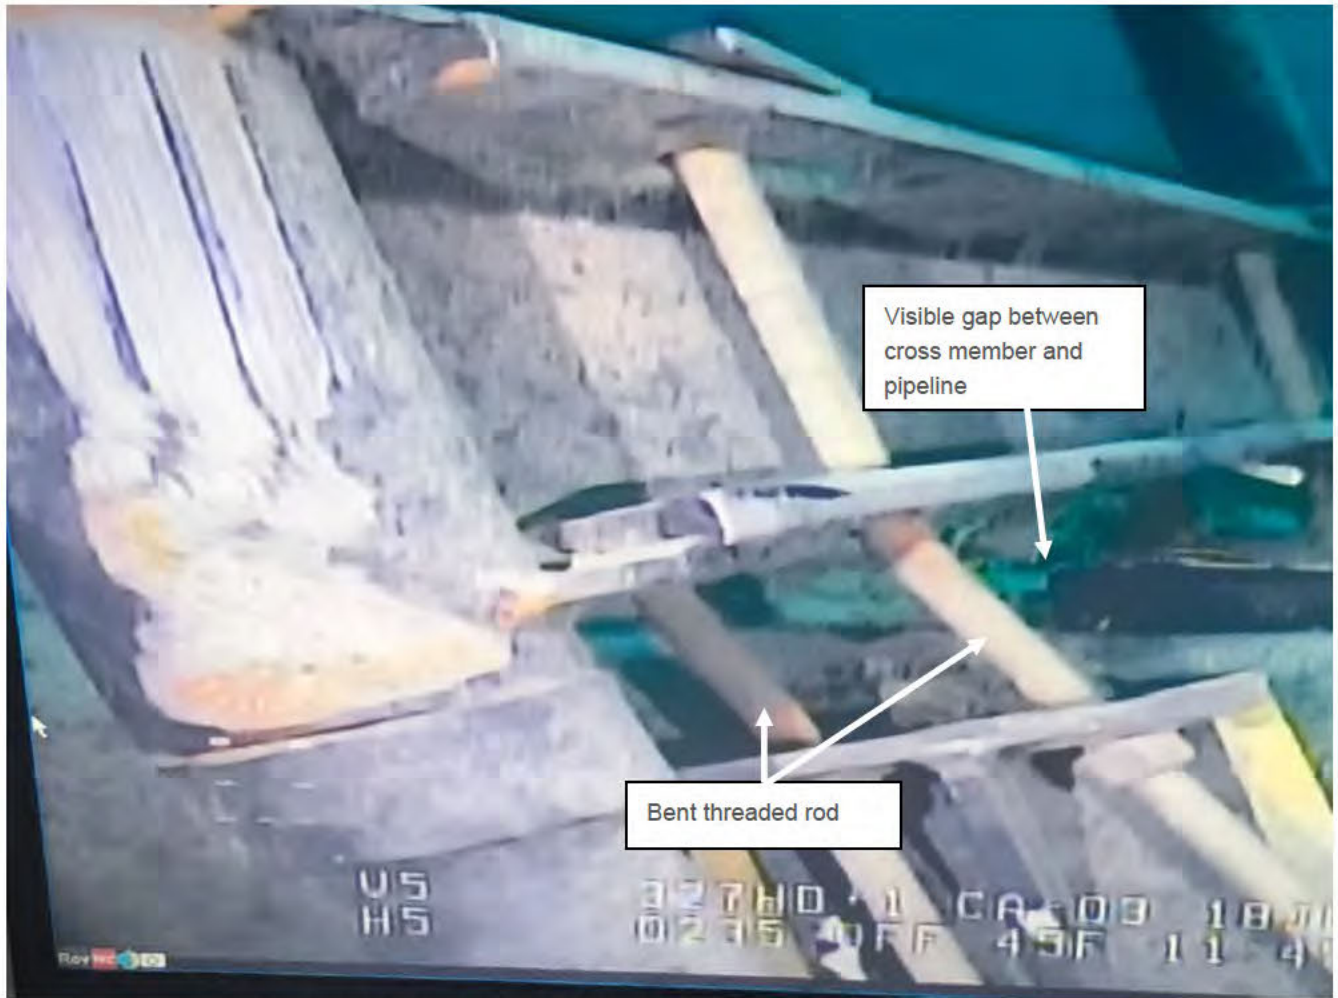
Figure 6: Damaged Threaded Rod Assemblies and Pipeline Gap to Cross Member

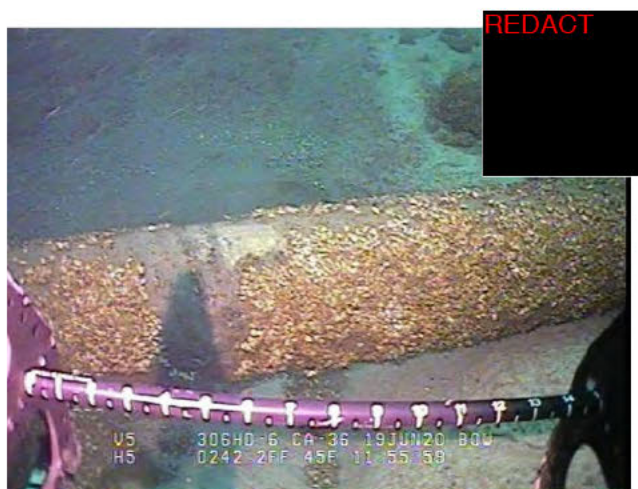
The feature of interest identified by ROV on the West leg is comprised of an area of disturbed biota (quagga mussel encrustation is removed) with a small light-colored patch (approximately 50 square inches). The light-colored patch are calcareous deposits formed by the proper operation of the cathodic protection system. The images show there was no bare metal or mechanical damage and the pipe was protected by coating and cathodic protection. The follow up dives confirmed all ROV findings, and additional details were collected. The feature measurements from Diver was found to be slightly larger (~70 square inches) than the estimate previously provided based on ROV images. The feature of interest did not require repair.

Figure 3: Feature of Interest (close)

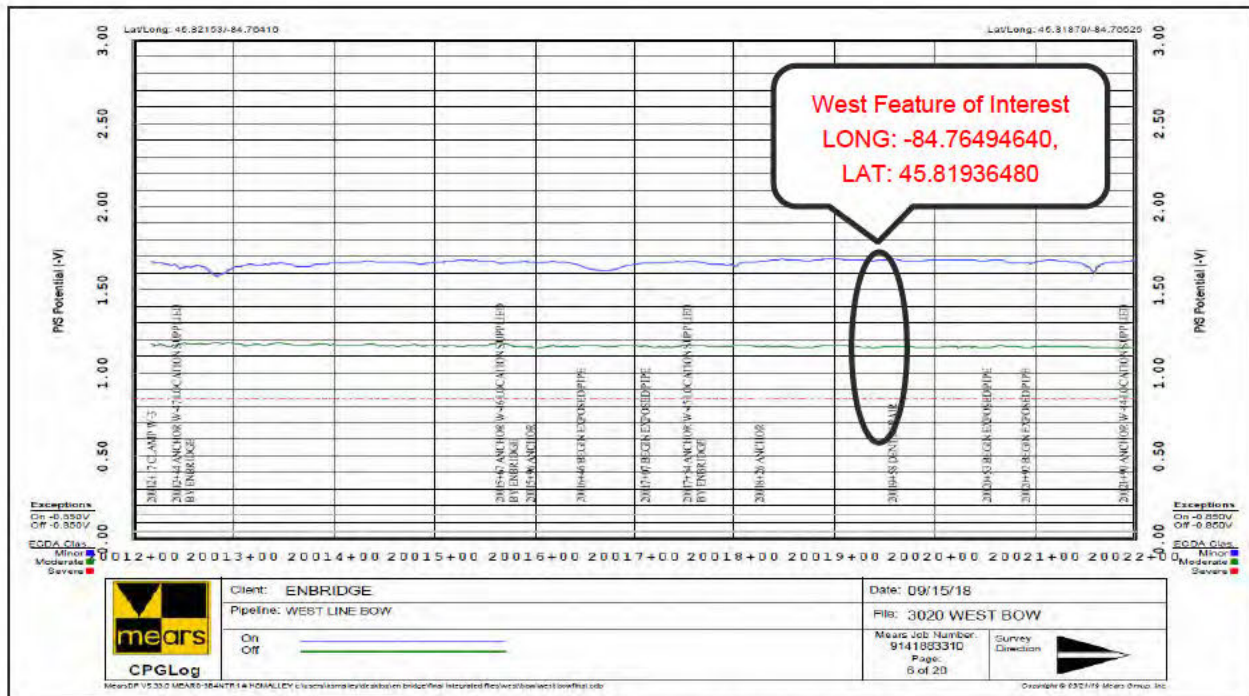
The area containing the feature of interest on the West pipeline was carefully examined for electrical variations to determine any signs of coating damage. No electrical anomalies were identified, indicating that there was insufficient exposed metal to alter local protection levels at the time of the CIS. Figure 4 presents the segment of survey containing the feature of interest, with the location of the feature highlighted.

Figure 4: CIS of the Segment Containing Feature of Interest (Feature identified)
